M E M O R A N D U M

DATE: October 25, 1989

SUBJECT: Weston Lower Dam - Weston

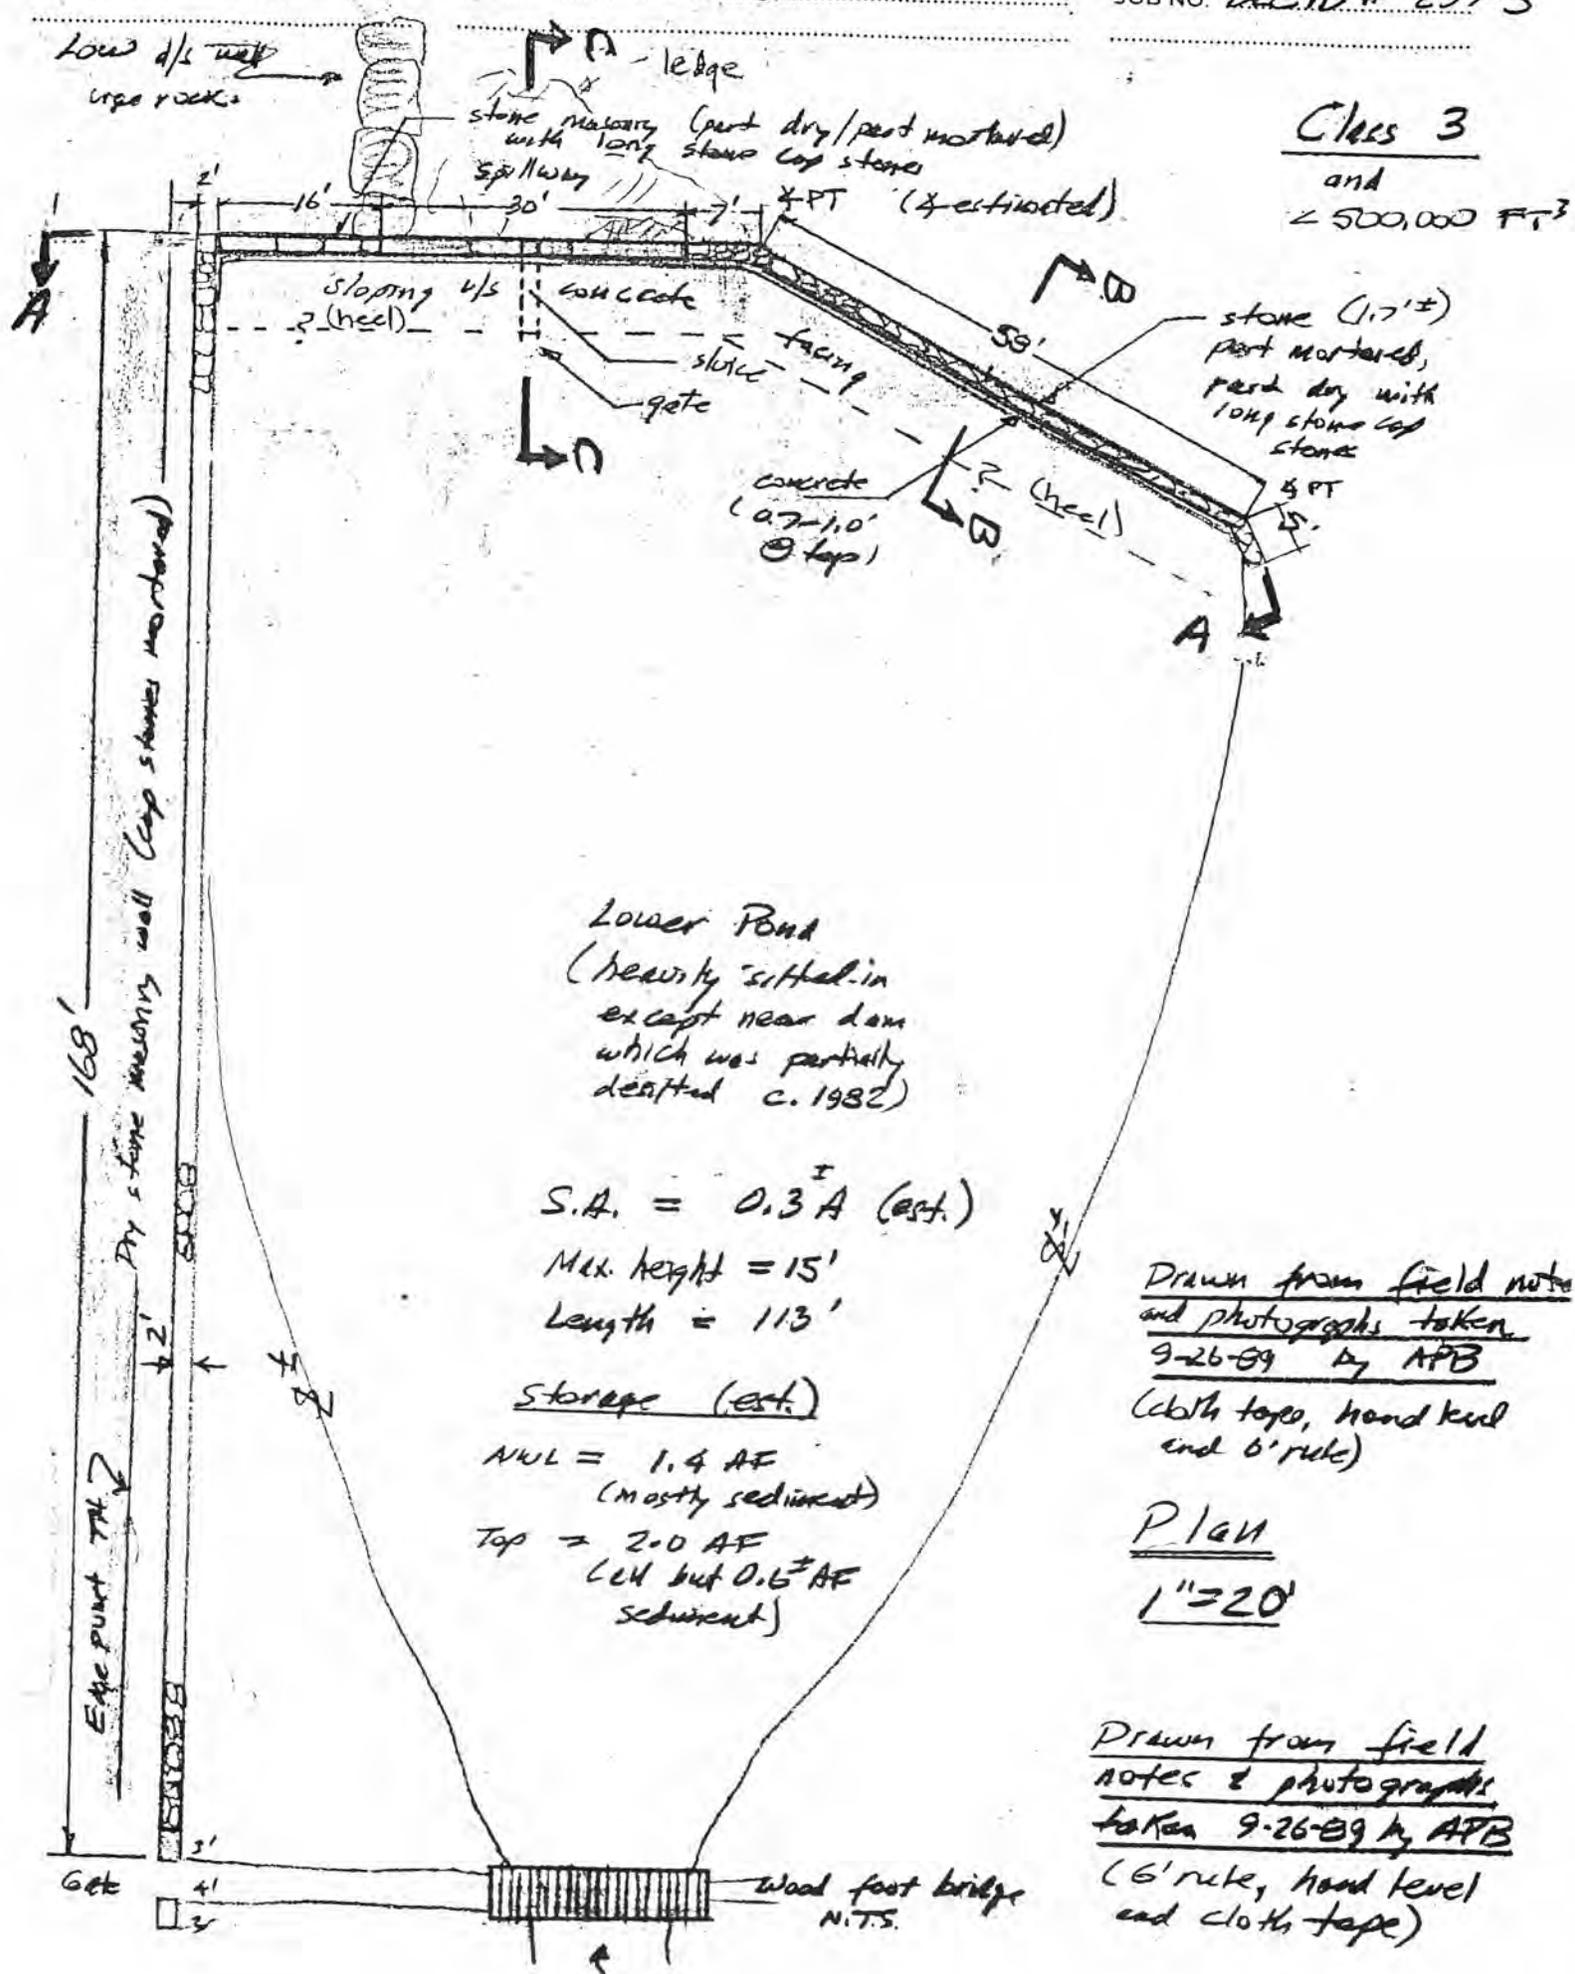
PLAN  
1"=20'

Lower Pond  
 (heavily silted in  
 except near dam  
 which was partially  
 destroyed c. 1982)

$S.A. = 0.3 A$  (est.)  
 Max. height = 15'  
 Length = 113'

Storage (est.)  
 NWL = 1.4 AF  
 (mostly sediment)  
 Top = 2.0 AF  
 (LH but 0.6 AF  
 sediment)

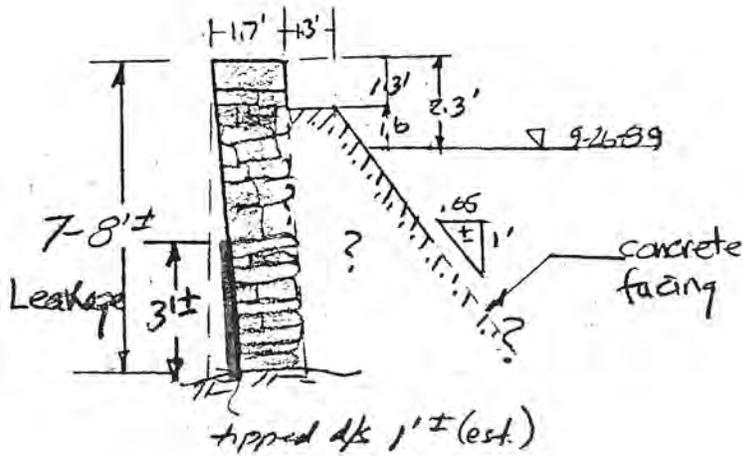
Section B-B  
Right side  
 (30'± from Rt. 3 PT)  
1" = 5' H&V

This is of the same construction as the left segment but is quite noticeably tipped downstream (1' - 1.5'). Some of the "new" mortar in the cap stone joints has cracked. These could be shrinkage cracks but there may be some recent downstream movement of the stones. Major leakage is located 1' - 3' above the toe line in a 30' zone beginning at right end. The heaviest leakage is at the right end of this zone. Bushes obscured most of downstream face and made it impossible to inspect in detail.

- ① Slope of ups concrete facing (both left and right) appears to vary. There are also cracks in the concrete facing.
- ② "New" (within last few years) mortar in cap stone joints on right side have  $\frac{1}{8}$ " -  $\frac{1}{4}$ " cracks. Possibly some d/s displacement of cap stones since mortared.
- ③ Weed and bushes along d/s too of right side made it impossible to adequately inspect this part. Also vegetated growth at left end of left side obscured dam.
- ④ D/S channel. Just below dam is private stone bridge with steel beams and wood deck - could be damaged by dam failure.

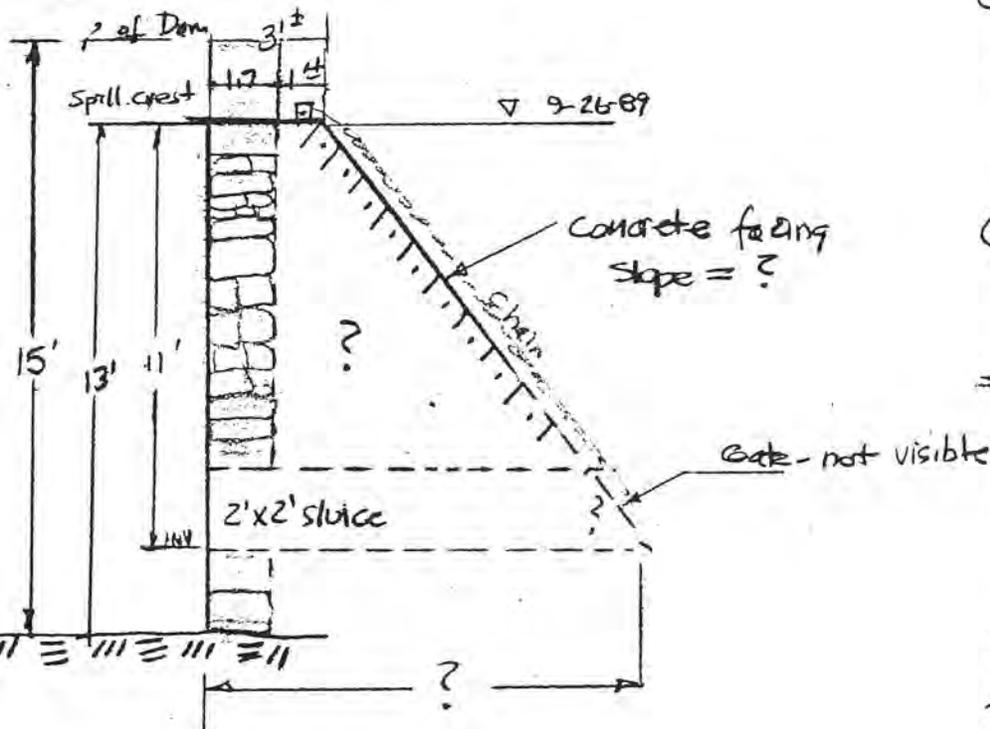
Section C-C  
Left side  
 (2' sluice at spillway)  
1" = 5' H&V

- a. Downstream Face. Appears to be tipped downstream. Stone work is intact. Leakage through most of downstream face (leakage pattern appears to be the same as in C. 1950's - 1960's, 1968 and 1979 photos). The upper part of the stone wall has been mortared in recent years - could not tell if an attempt had been made to mortar it in area of leakage. Brush growing in earthfill along left toe above downstream stone wall obscures downstream face.
- b. Crest. Cap stone are in place but a little irregular in alignment and elevation - lower on right end of spillway. Appears to be some movement downstream near angle point due to tipping.
- c. Upstream Face. The upstream concrete facing was submerged but partially exposed - apparently when the dam was partially desilted in 1982. Some

cracks are visible but facing appears to be continuous. What is between concrete facing and downstream stone wall is unknown. Due to the large amount of leakage visible on the downstream face it appears that the interior material is flooded to pond level. The facing appears to provide little leakage control in this part of the dam.

- d. Spillway. Unobstructed and intact.
- e. Sluice. The downstream portal was unobstructed. Leakage with rust deposits evident. The rather flimsy crank type gate operator is located on spillway crest above the sluice. A chain is attached to it and runs down the sloping concrete face to the gate. It is not known if this is operable.
