August 7, 1996

Re: Cold Brook Dams - Monitoring  
DH 415003

Dufresne-Henry submitted dam evaluation reports on the Upper and Lower Cold Brook Dams in August 1993. The dams were judged to be in poor to fair condition with the Lower Dam the worse of the two. It was a recommendation that a monitoring program be established at the Lower Dam to quantify movement, if any, over time. At the direction of the Commission, a monitoring program was established at both of the Cold Brook Dams.

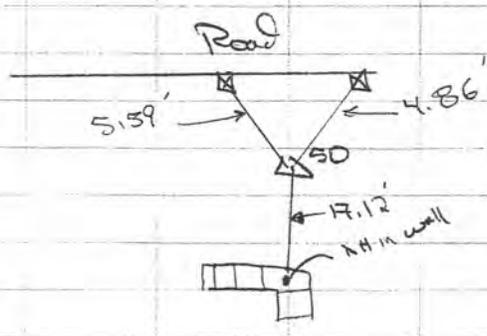
Upper Dam 5/3/95

85 reof	45 reof		
(50)	(51)	100.81	
Drill Hble	(71)	17.11	
"	(72)	27.74	
"	(73)	38.12	
"	(74)	47.52	
"	(75)	56.23	
"	(76)	64.30	
"	(77)	72.62	
"	(78)	74.00	
Traverse	(1)	38.81	(-) 103-42-34

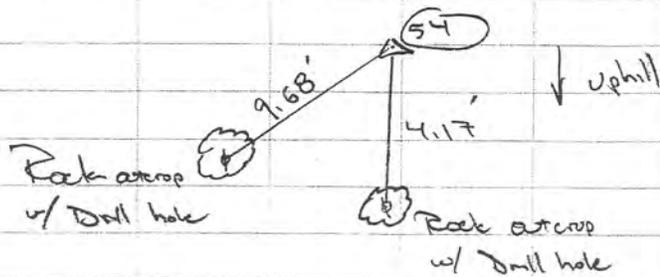
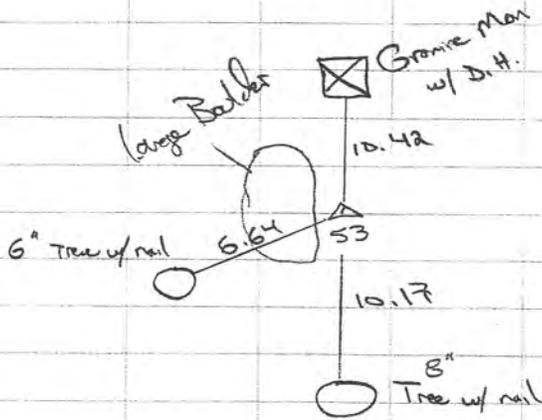
Lower Dam

(52)	(53)	174.070	
Drill Hole	79	42.360	
"	80	50.050	
"	81	56.545	
"	82	61.055	
"	83	66.940	
"	84	74.885	
"	85	80.960	
"	86	85.780	
"	87	89.305	
"	88	94.495

(54)	(55)	229.160	
Drill Hole	(89)	42.515	
	(90)	63.715	
	(91)	79.640	
	(92)	92.805
