M E M O R A N D U M

FROM: A. Peter Barranco, Jr., P.E., Dam Safety Engineer
DATE: October 25, 1989
SUBJECT: Weston Upper Dam - Weston

On September 26, 1989 the writer inspected subject dam at the request of Roy E. Varner, a representative of the owner, Weston Community Club, Weston, Vermont. Mr. Varner's mailing address is RR #1, Box 106-D, Weston, Vermont 05161; telephone 824-8172. The purpose of the inspection was to evaluate the condition of the dam and to make any recommendations regarding the dam and desilting the pond. The inspection was carried out under provisions of 10 V.S.A. § 1105.

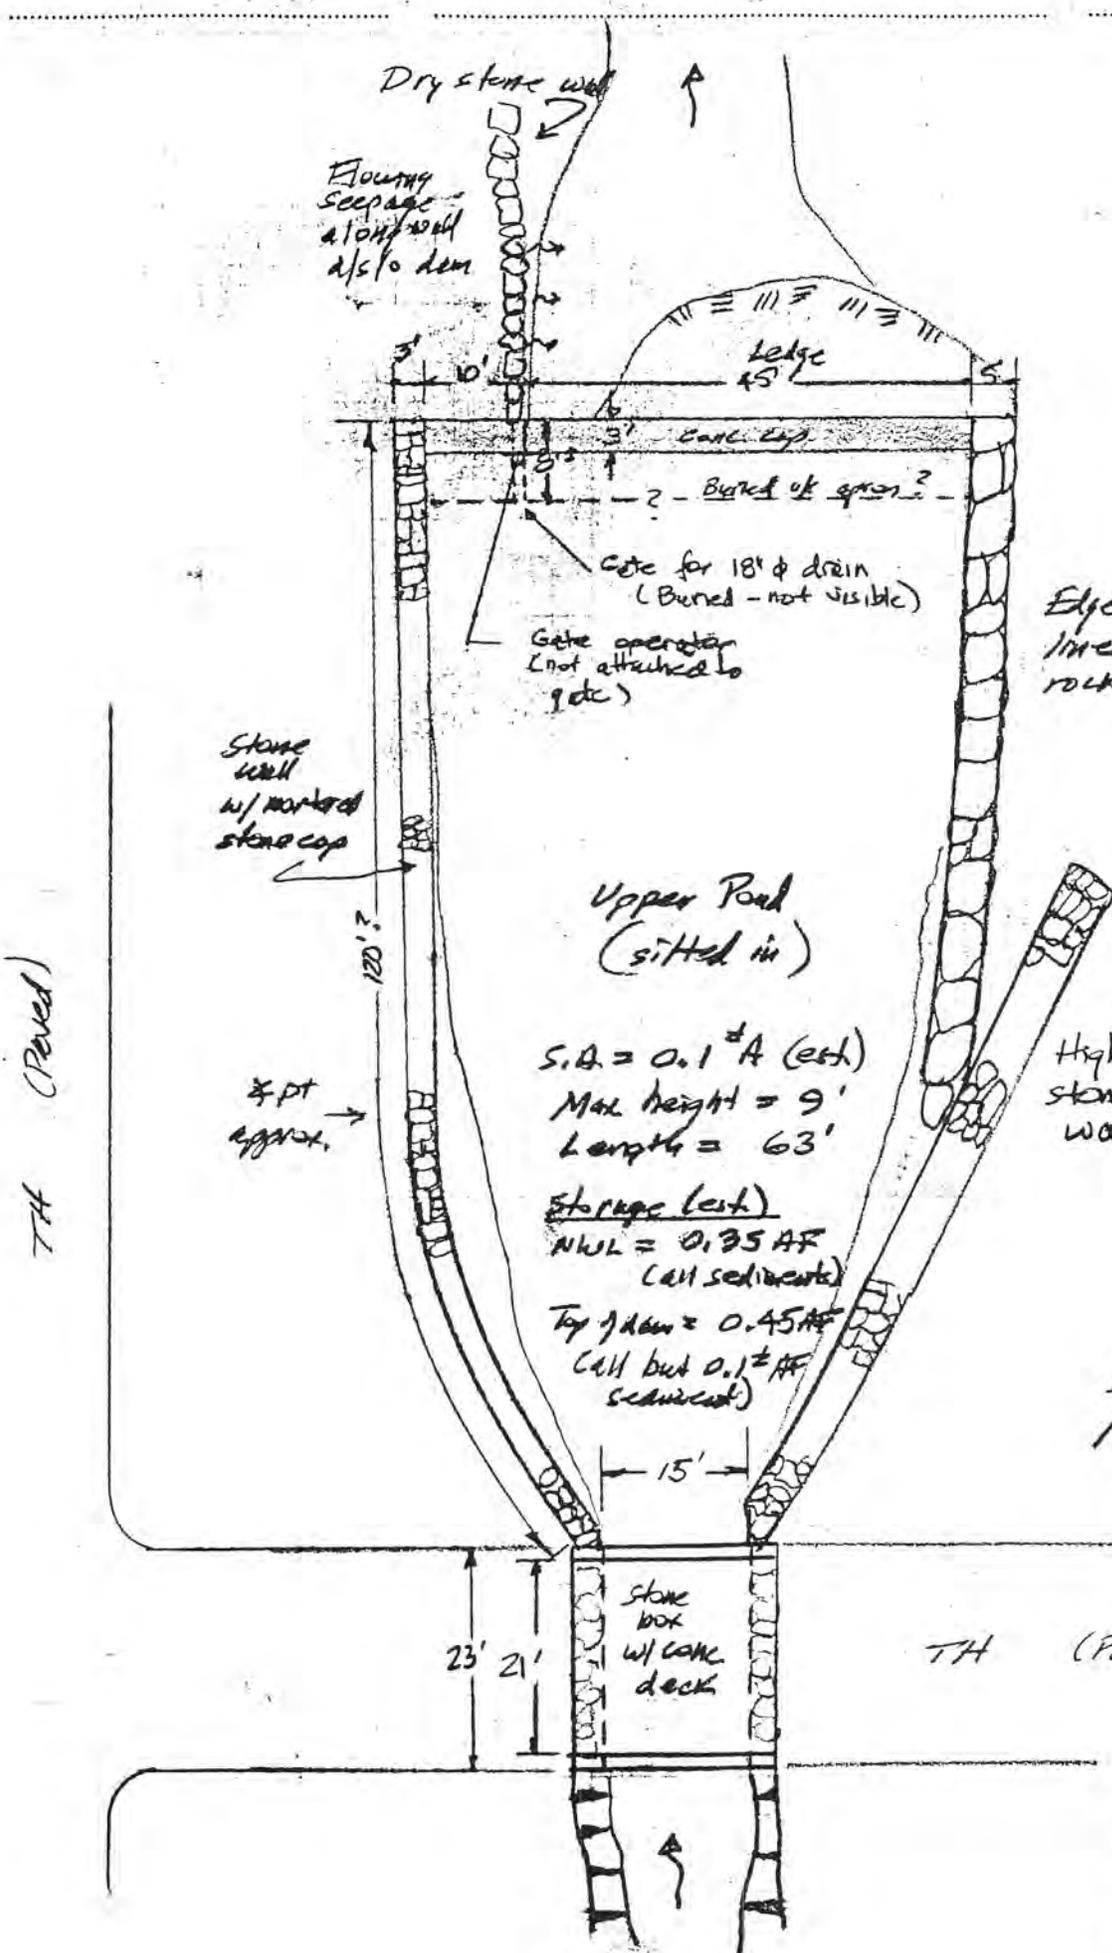
The dam is a dry rubble stone masonry gravity structure 63' long and 9' high founded for the most part, it appears, on ledge. It has a top width of 3' and vertical downstream face. A 45' long by 1.1' deep spillway with a flat 3' wide concrete capped crest is provided in the central part of the dam.

There is a void about 8' long, 1' high and 4' deep along the toe starting at a point below the left end of the spillway. The bottom of the void is ledge. There are a number of loose stones that may have come from this void. It is not clear what keeps other stones from falling in this area. It was not possible to see into the void due to overflowing water. Some leakage in void and some rust deposits.

Class 3
 and
< 500,000 FT³

Alignment of both
wells is approx.

Upper Pond
 (silted in)
 $S.A. = 0.1 A$ (est.)
 Max height = 9'
 Length = 63'
Storage (est.)
 $NWL = 0.35 AF$
 (all sediments)
 $Ty \uparrow dam = 0.45 AF$
 (all but 0.1 AF
 sediment)

1. Owner should have a qualified professional engineer experienced with dams further investigate the void under the left downstream toe and design and supervise construction of needed repairs. If the dam is desilted, a further evaluation of the dam should be made by owner's engineer.
2. Cut brush along downstream face so dam can be better observed.
3. Provide routine monitoring to observe any changes that might further effect the dam. Observations during "high water" conditions is also important.
